Structural assessment of a fire damaged Highway Bridge in Lagos-Nigeria with BRIMOS[®] Structural Health Monitoring

R. Veit-Egerer, M. Widmann and P. Furtner
VCE Holding GmbH, Vienna, Austria

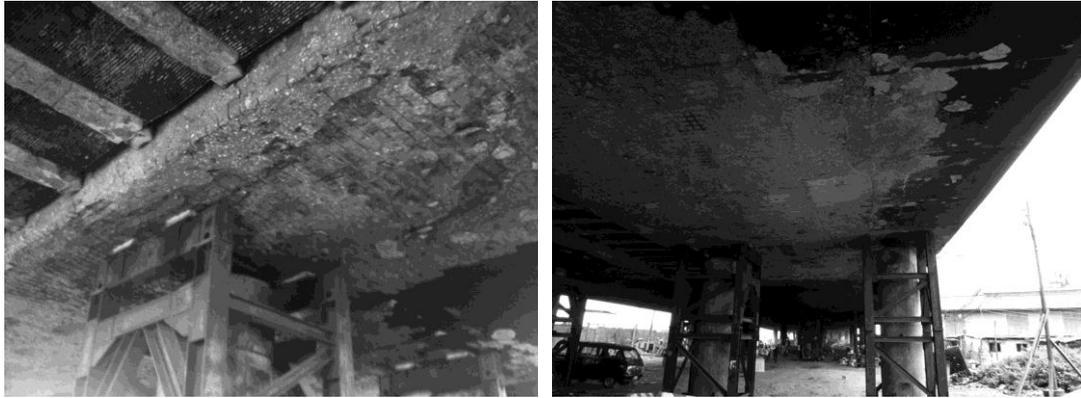
Parallel to the dynamic measurement an accompanying rapid visual inspection was carried out. As expected, the underside and the piers at the area of span 2, 3 and 4 show severe damage caused by the fire. For further details see Julius Berger Nigeria PLC (2008). The expansion joints are in poor condition due to lack of maintenance. Parts of the railing and almost all man-hole covers are missing.

Figure 3 : Visual impression of fire damaged bridge sections.

- The delaminated concrete at the bridge deck's bottom side should be removed with high pressure water blasting.
- The damaged reinforcement and concrete cover has to be replaced.
- A strengthening of the spans 2, 3 and 4 by external prestressing is recommended.
- Damaged bearings are to be replaced. A proper replacement concept is to be elaborated and implemented, which could be combined with a replacement/retrofit program of the damaged piers.
- The damaged expansions joints intensify the force transmission into the structure and contribute to the high vibration intensity. Therefore a replacement of all damaged expansion joints is recommended.
- A static recalculation addressing the bridges post-tensioning is recommended - considering the failure of the lower tendon layer caused by fire.

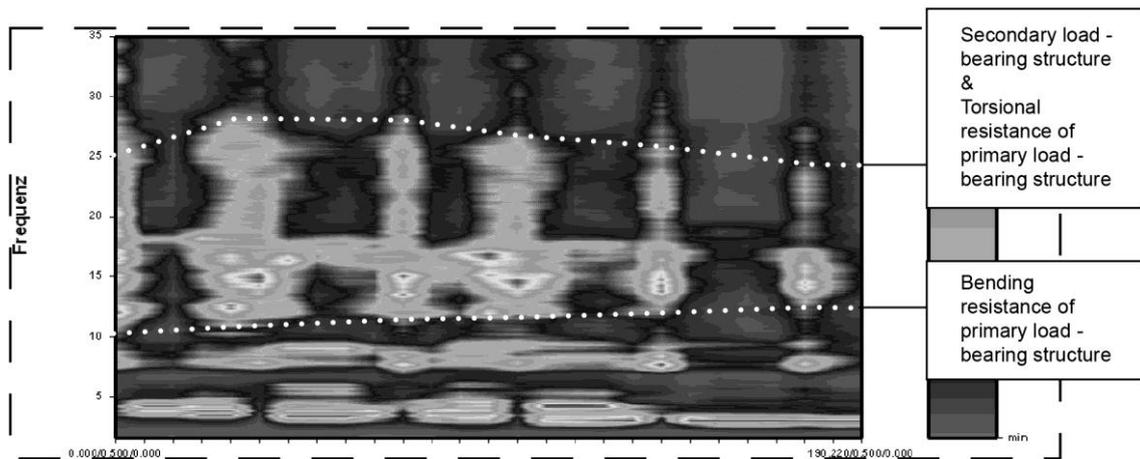
Figure 7 : Distribution of stiffness in the lengthwise direction, 1.5-35 Hz (vert.) - Eko mainland Center

The present investigation aims on an evaluation to what extent the bridge's operability and load-bearing capacity was affected by the fire. For that purpose the trend cards showing the structure's relevant vertical stiffness patterns in the lengthwise direction emerged to be the most suitable instrument. For every measurement two trend-cards were derived. The first one shows the bridge's relevant stiffness patterns in the range of 1.5 to 35 Hz (Figure 7) the second one illustrates the range of 1.5 to 10 Hz in detail (Figure 8).

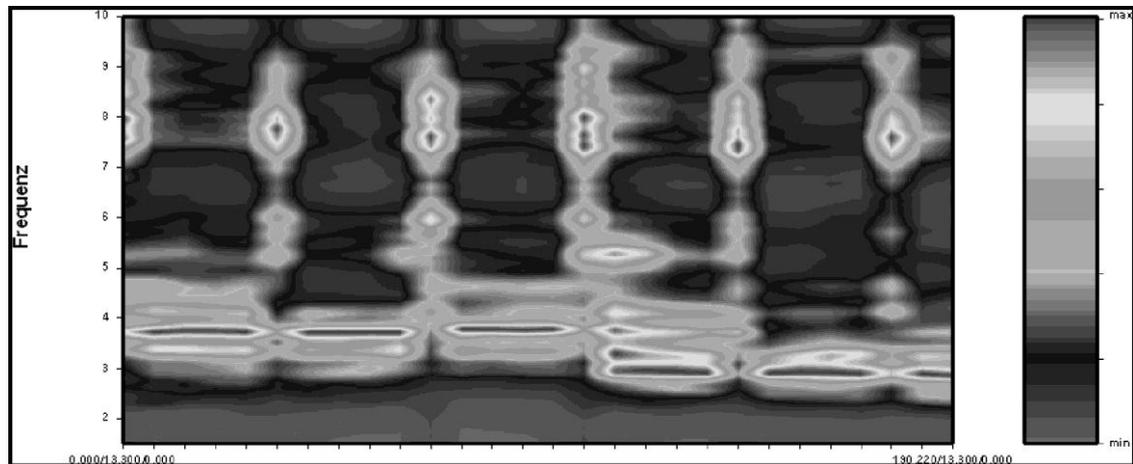
Figure 8 : Distribution of stiffness in the lengthwise direction, 1.5-10 Hz (vert.) - Eko mainland Center

In fact the damage led to an considerably reduced bending resistance of the primary load-bearing structure at the affected regions of span 1, 2 and 3 (Figure 8). The analysed mode shapes confirm the presence of the addressed bending resistance but at the same time the trend cards underline their lack of availability in the course of load bearing activity due to their minor visibility (Figure 7). This causes a redistribution of the internal forces to the higher frequency range leading to an intensified stressing of the torsional resistance of the primary load-bearing structure and the secondary load-bearing structure (Figure 8).

Furthermore trend cards of vital structures usually show a clear separation between pier and span areas (confirming the proper development of designed stiffness-concentrations). While this necessary attribute is visible for the spans 4 & 5, the rest of the bridge (spans 2 & 3) indicate an inefficient force transmission, as the described separation becomes indistinct (Figure 8).

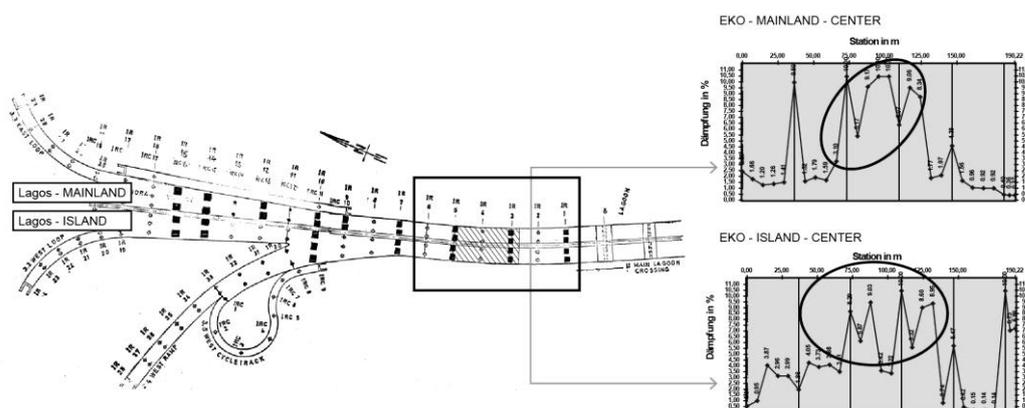
The given results confirm the operability of the bridge in principle. Parts of those areas where the bridge was damaged by the fire impact clearly show increased damping values indicating reduced bending and torsional resistance.

Figure 9 : Overview – Exemplary RDT-Damping patterns - confirming heavy damage.
