Experience made with the International Benchmark on Dynamic Bridge Monitoring and Assessment at the Wayne Bridge in New Jersey

ABSTRACT: A representative composite bridge has been selected by the Federal Highway Administration (FHWA) for the international collaboration between the Long Term Bridge Performance Project (LTBP) initiated in the U.S. and the FP7 Project IRIS in Europe. Various teams from the U.S., Japan, Korea, UK and EU have performed separate assessment routines including dynamic monitoring and system identification. The various approaches were compared and harmonised in order to achieve a standard model for this type of bridge, representing more than 40% of the bridge stock in the FHWA network. This comprises a total of about 240.000 bridges which could subsequently be tested and assessed following a standard procedure. The present paper intends to present a strongly life-cycle oriented approach, developed by the authors. This is based on a dynamic monitoring campaign and an accompanying visual inspection at the Wayne Bridge, New Jersey.

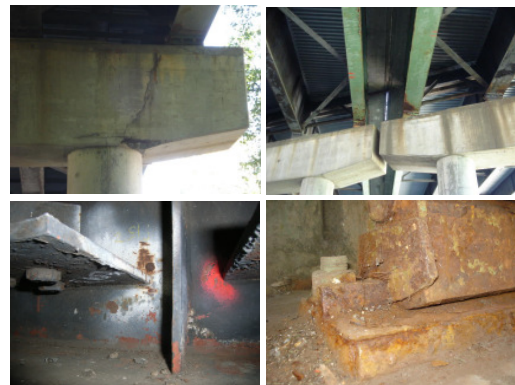
The inspection did not show any extraordinary findings in addition to what has been documented before or reported by the other teams. Basically the structure appeared to be in fair condition with existing local problems (Figure 2).

The damages point out the typical issues of corrosion and cracking. Corrosion can be mainly attributed to water leaking from the expansion joints and the activities of the pigeons. Most severe damages are to be seen at the abutments and comprise mainly the end cross girders. The corrosion protection of the outer steel beams is intact which gives the bridge a reasonable appearance. Generally the corrosion condition of the main girders is good. The concrete parts of the structure also show a very reasonable appearance. There is

The cracks in the steel structure are mainly attributable to improper detailing of the structural steel components. Bracings - directly connected to the webs - without the required respective stiffeners on the opposite side invite damages. This creates an overstress in case of differential movement. Nevertheless this problem is most probably not progressive after the initial overstress has been released by cracking. Furthermore this damage concentrates on parts of the steel structure which are not the main bearing elements. Therefore any collapse without warning can be excluded. No immediate intervention is necessary.

The abutments are cracked at the wing walls as well (both abutments, both sides). Looking at the abutment situation from the top it shows that there are water traps where water is invited to seep into the embankment behind the abutment wall. Freeze and thaw circles might have created the problem of cracking.

Concrete spalling with the appearance of local corrosion is to be seen on one of the piers. The corbel supporting the outer beam of the southbound structure (pier dividing span 1 and 2) is cracked. As this structural detail appears several times and the loading in this particular place is assumed to be far from being excessive this damage might also be caused by construction activities. Eventually a temporary overloading caused the cracks which subsequently allowed corrosion of the reinforcement. As there is sufficient redundancy at this particular place of the structure no immediate action is required.

Figure 2. Typical findings at the Wayne Bridge

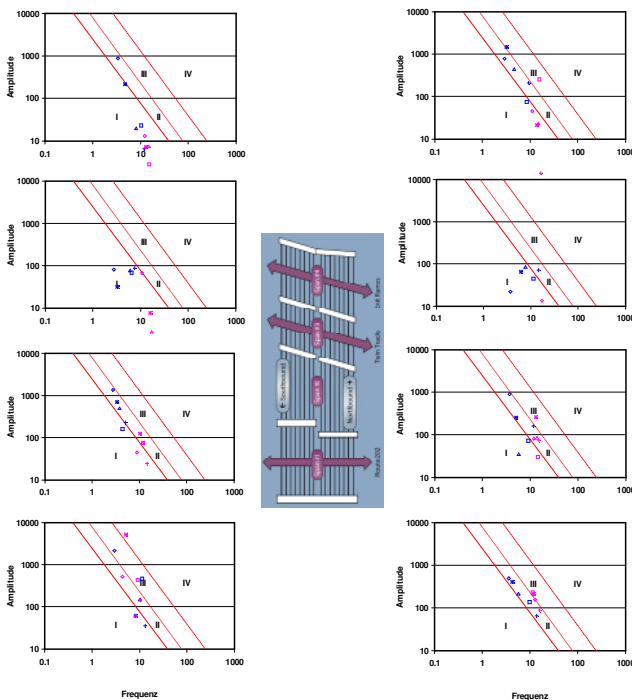
The vibration intensity determined for all the existing outer beams is shown in the following Figure 15. The bridge object responds sensitive to traffic impact loading and shows values of vibration intensity in the range I and II but also already increased values in the range III. Range II indicates a zone, where damage might be caused by continuous dynamic stress. Range III indicates a zone, where permanent dynamic stressing causes damage to substantial parts of the structure.

The frequently occurring fatigue cracks are considered to be obviously consequences of the high vibration intensity. The damaged and probably too small dimensioned expansion joints intensify the force transmission into the structure and contribute to the high vibration intensity.

The frequency which is excited the most from traffic is located around 10 Hz and represents either the 4th or 5th vertical eigenmode. This frequency occurs in intensity level IV once (span 1 southbound), in intensity level III 3 times (span 1, 2 and 4 northbound) and in intensity level II for the rest of the spans.

Intensity IV is definitely a damaging level and corresponds with the cracks found in the deck slab in span 1 southbound. A loading impact that regularly occurs in intensity zone III means that in the medium-term damage from vibration shall be expected. Consequently this will most probably cause further crack patterns in the deck slab within the next five years.

Figure 15. Distribution of Vibration Intensities over the Bridge

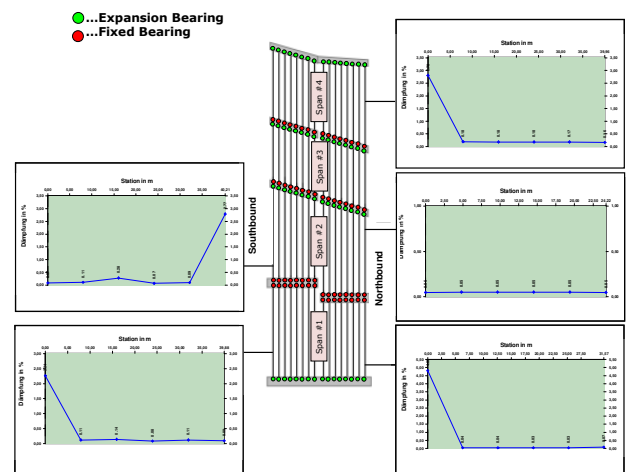
The given results show 3 regular cases and 2 cases of extraordinary behaviour.

Span 2 northbound does not show any energy dissipation indicating that the moveable bearings are not excited to any movement from dynamic loads. This indicates a malfunction of these bearings which might lead into overstress in the beams.

At span 4 northbound energy dissipates at the “wrong” bearings, which might either mean that there is a mistake in the drawings or the fixed bearings are malfunctioning (these bearings have not been inspected).

Figure 16. Recorded Energy Dissipation Paths.

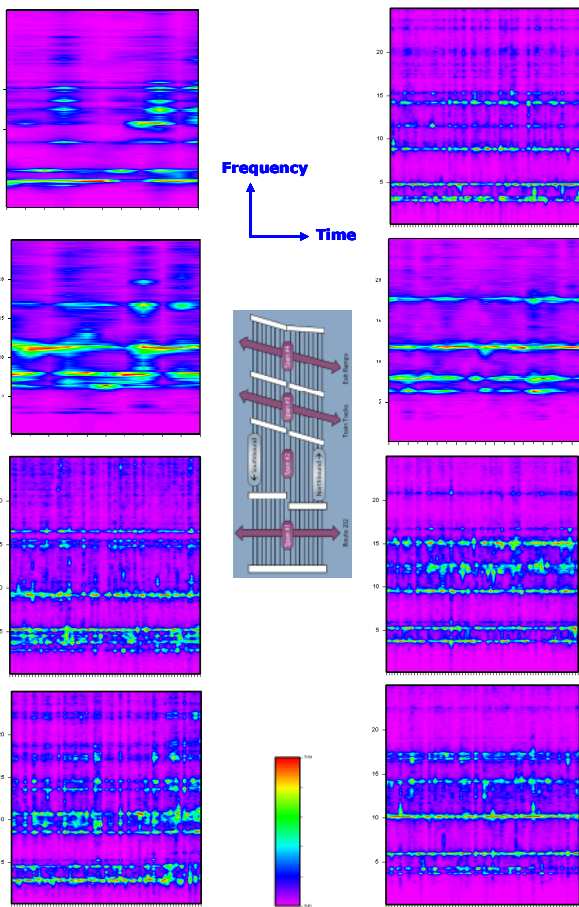
For every span of the bridge object related trend-cards were derived. Figure 17 shows the spans' relevant stiffness-patterns in the vertical direction over the measurement's entire time period in the range from 0.2 to 25 Hz represented by the reference sensor defined for each span. The different quality of the trend cards depend on the total length of records available. The eight trend cards given here do not show any unusual behaviour and therefore confirm that the global structural behaviour is satisfactory. Considering the high vibration intensity given before this is a sign that there is no damage affecting the global structural behaviour yet. Extraordinary changes indicating arising deficiencies can not be detected in any of the trend-cards.

Figure 17. Trend Cards over the entire recording Period for all Spans

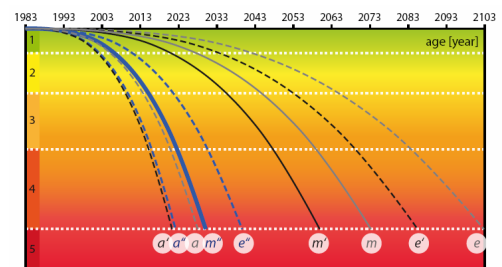
It is shown that under the current circumstances the theoretical remaining lifetime is estimated to be 21 years only (Figure 18). The result meets the expectation that without any retrofit the lifetime of the structure is limited.

Figure 18. Derived Life Cycle Curve (Condition Index) enhanced Model => Range of Life Expectancy.

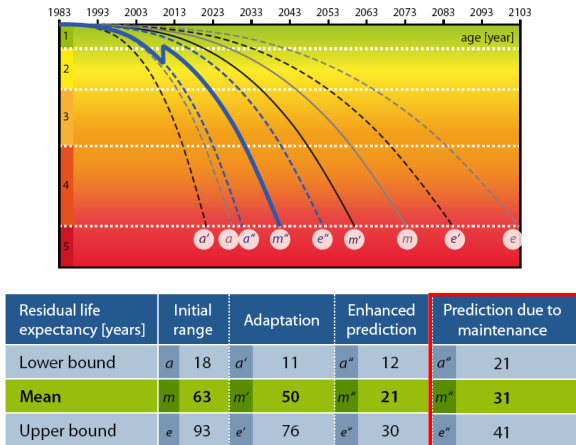
In case that the bridge receives the proposed retrofit durability issues and above all a reduction of the intensive vibration to reasonable levels are most likely ensured. The remaining lifetime of the structure can be expected to increase to at least 31 years (Figure 19).

Figure 19. Derived Life Cycle Curve (Condition Index) enhanced Model incl. Maintenance Interventions => New Range of Life Expectancy.

Renewal of corrosion protection, repair of the concrete surface and the corroded stringers, replacement of the wind bracings to handle the problems with the occurring fatigue cracks, and proper replacement of the bearings

Renewal of corrosion protection, repair of spallings, holes and concrete pockets as well as removal of contamination of the concrete surface, deep injection of cracks

Establishing of an effective drainage concept

Proper detailing & design

- Full replacement (abutment area) or
- Partial replacement (at least seals above the piers)
