Structural assessment of a fire damaged Highway Bridge in Lagos-Nigeria with BRIMOS[®] Structural Health Monitoring

R. Veit-Egerer, M. Widmann and P. Furtner
VCE Holding GmbH, Vienna, Austria

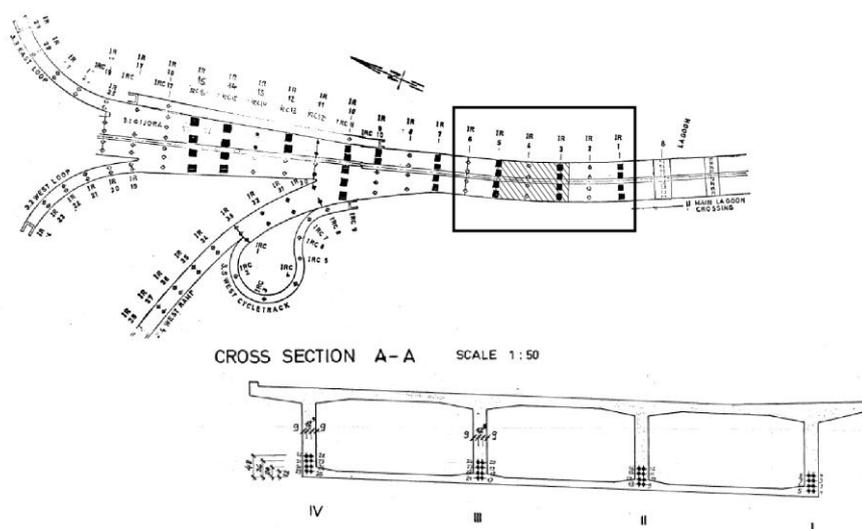
Figure 2 : Plan (top) and cross-section view (bottom) of the investigated part of Eko Bridge.

Deviations between the eigenfrequencies of the different structures primarily arise from the different geometrical properties (the ground view progression causes varying span lengths - see Figure 2).

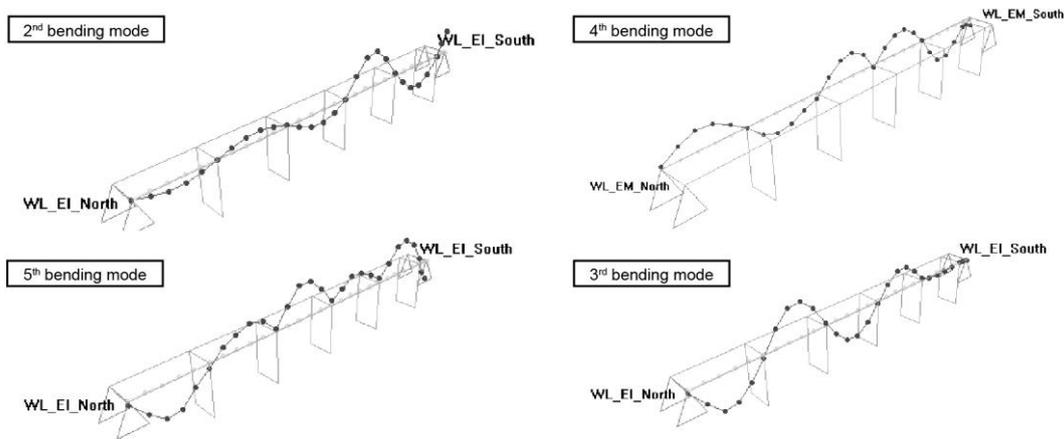
Figure 6 : System Identification – Resonance frequencies vs. type of structural response.

The determined mode shapes are characteristic for this kind of structures and correspond to the expected modes of vibration. Several representative mode shapes for the left and the right structure are presented in Chapter 3 (Dynamic system identification – Figure 6). Although the load-bearing capacity is limited (poor developed frequency spectra) the determined mode shapes indicate that the bridge's operability is available in principle.
