Experience made with the International Benchmark on Dynamic Bridge Monitoring and Assessment at the Wayne Bridge in New Jersey

ABSTRACT: A representative composite bridge has been selected by the Federal Highway Administration (FHWA) for the international collaboration between the Long Term Bridge Performance Project (LTBP) initiated in the U.S. and the FP7 Project IRIS in Europe. Various teams from the U.S., Japan, Korea, UK and EU have performed separate assessment routines including dynamic monitoring and system identification. The various approaches were compared and harmonised in order to achieve a standard model for this type of bridge, representing more than 40% of the bridge stock in the FHWA network. This comprises a total of about 240.000 bridges which could subsequently be tested and assessed following a standard procedure. The present paper intends to present a strongly life-cycle oriented approach, developed by the authors. This is based on a dynamic monitoring campaign and an accompanying visual inspection at the Wayne Bridge, New Jersey.

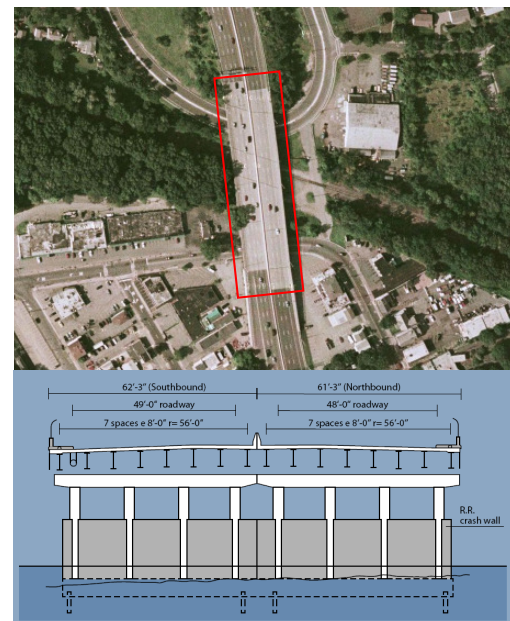
The bridge shows numerous fatigue cracks, bearing problems, joint performance problems, flexibility/vibration problems, extensive deck cracking and movements [4]. The overall condition rating (D.O.T. Bridge inspection) was fair – due to the superstructure [1][2].

Figure 1. Overview of the Wayne Bridge in New Jersey

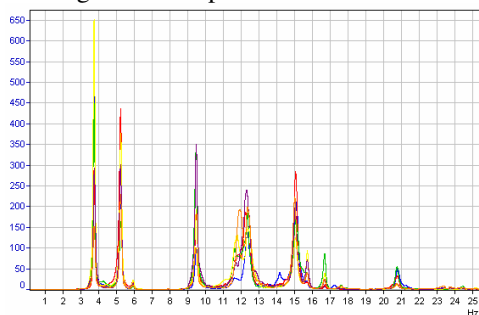
The frequency spectra (e.g. Figure 11) of all spans show a clear dynamic character in all three analysed dimensions. The relevant eigenfrequencies are primarily located in the range of 3.0 to 21.0 Hz. All of those eigenfrequencies are global eigenfrequencies (bending and torsion) linked with the dynamic stressing of whole spans.

Figure 11. Typical frequency spectra (ANPSD), 0.2-25 Hz, vertical direction, Span 2, Northbound Structure

Deviations between the eigenfrequencies of the different spans primarily arise from the different geometrical properties (geometry: skew progression - ground view, span length and section height). The measured deviations correspond with the expected ranges. No extraordinary characteristics indicating

limited operability or damage of the primary load bearing structure have been identified.
